Seek Now Maestro Report

Solo Inspection

Claim: 00000000

Loss Location : 123 Address Lane

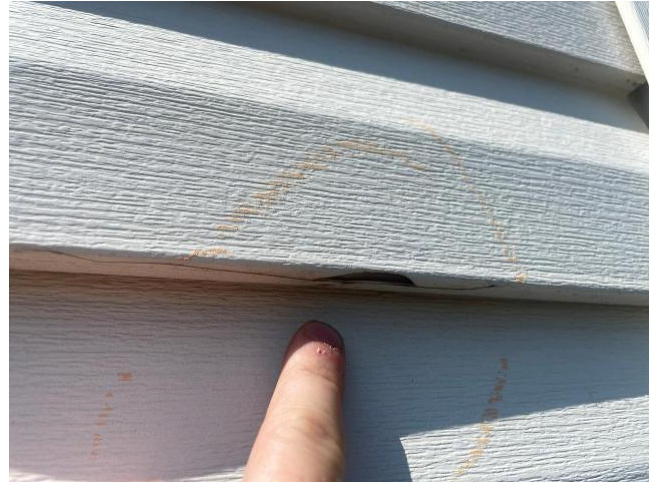
Elevation - Materials - Front - Damage

Main Material: Vinyl Siding

Storm related damage caused by Hail

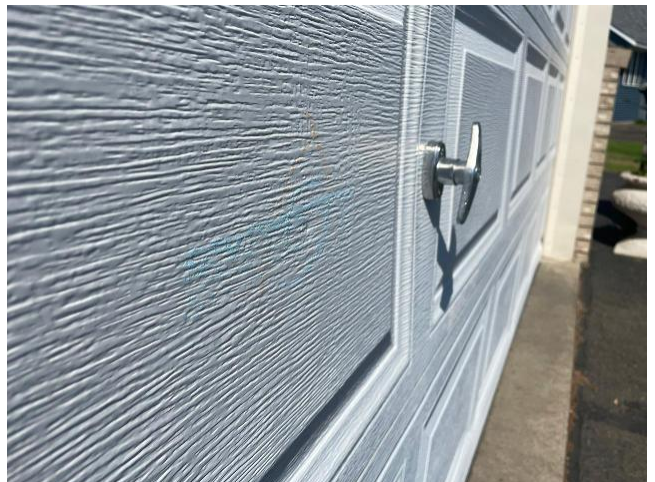
Elevation - Garage Door - Front - Item Photo

Storm related damage caused by Hail

Condition: Fair

Damage to Panel

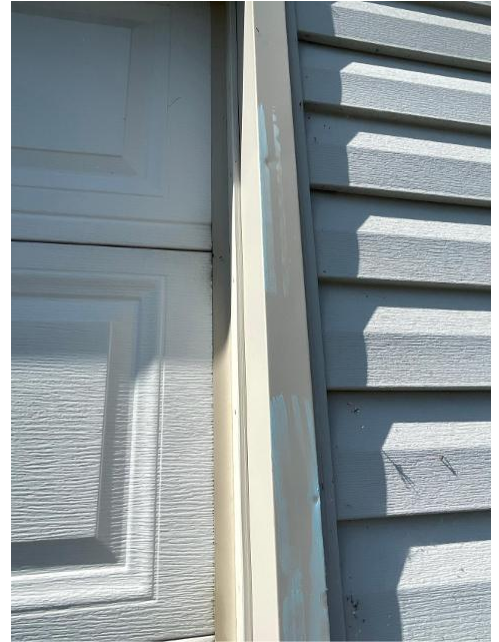
Elevation - Garage Door - Front - Item Photo

Storm related damage caused by Hail

Condition: Fair

Damage to Panel and Wrap

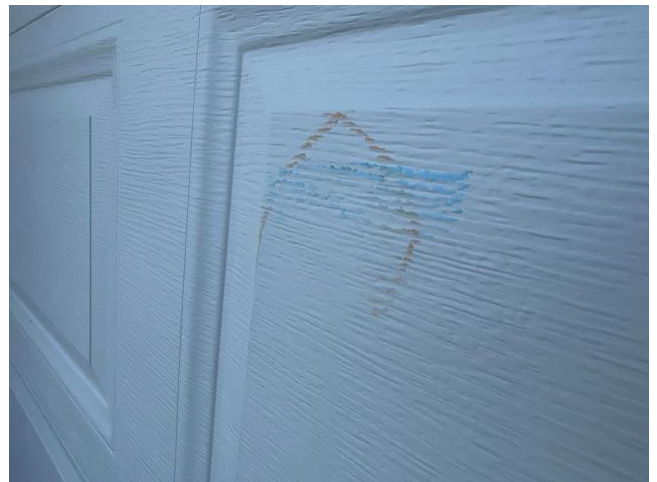
Elevation - Garage Door - Front - Item Photo

Storm related damage caused by Hail

Condition: Fair

Damage to Panel and Wrap

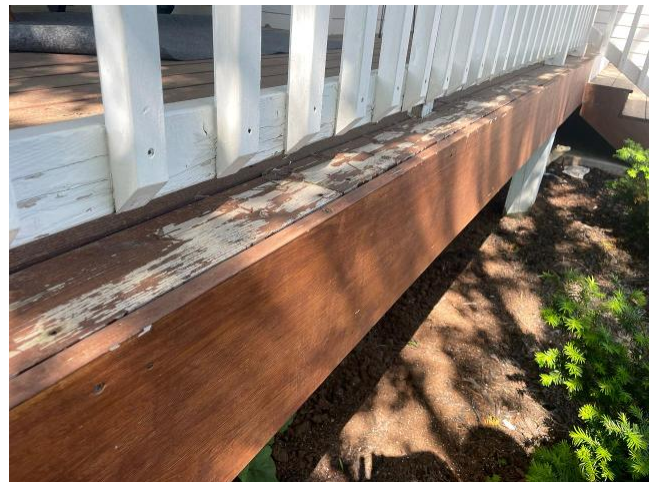
Elevation - Porch - Front - Insured Representative Considerations

Contractor included for damage consideration. Seek Now Inspector believes to be deterioration.

Note: Contractor claiming hail damage to wood.

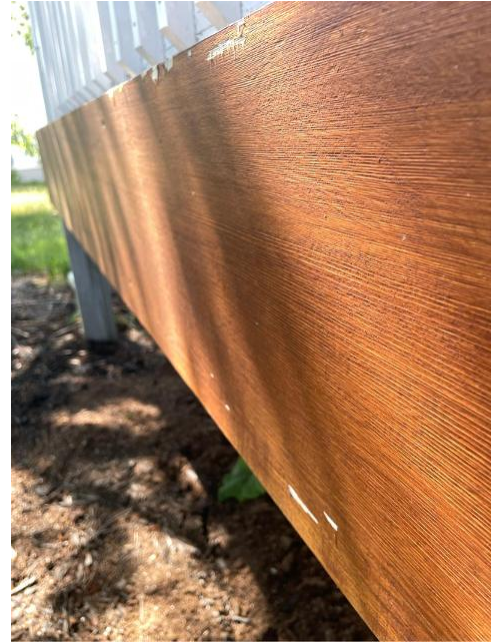
Elevation - Porch - Front - Insured

Contractor included for damage consideration.
Seek Now Inspector believes to be deterioration.

Note: Contractor claiming hail damage to wood.

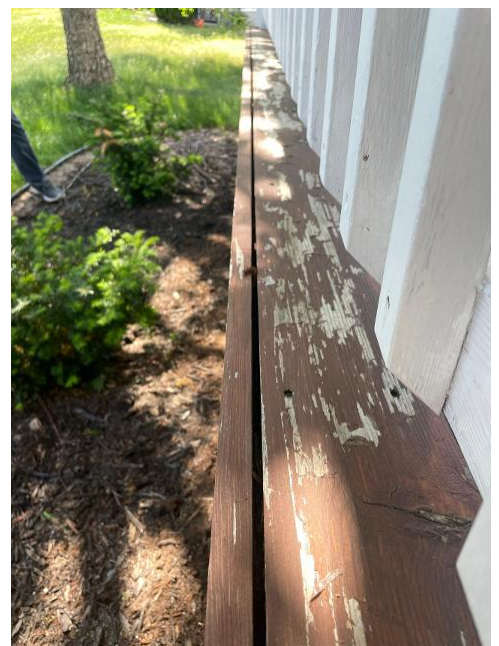
Elevation - Porch - Front - Insured

Contractor included for damage consideration.
Seek Now Inspector believes to be deterioration.

Note: Contractor claiming hail damage to wood.

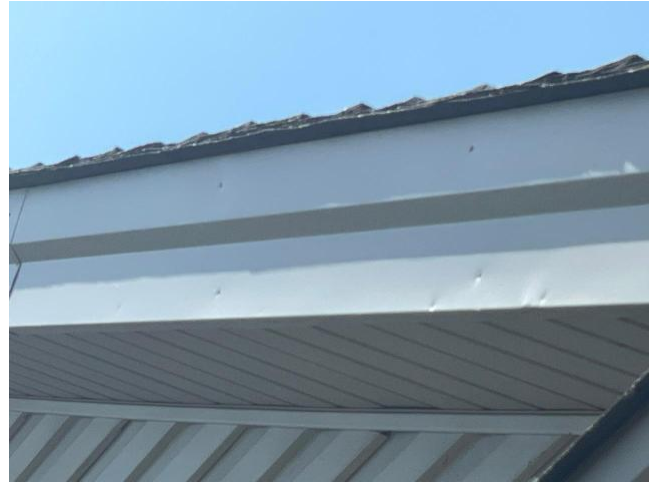
Elevation - Front - Fascia

Storm related damage caused by Hail

Condition: Fair

Damaged : 30 LF of Aerial

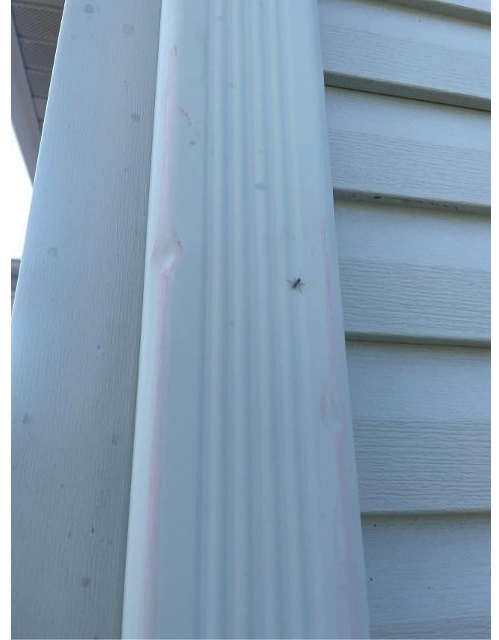
Elevation - Right - Downspout

Storm related damage caused by Hail

Condition: Fair

Damaged : 20 of 20 LF

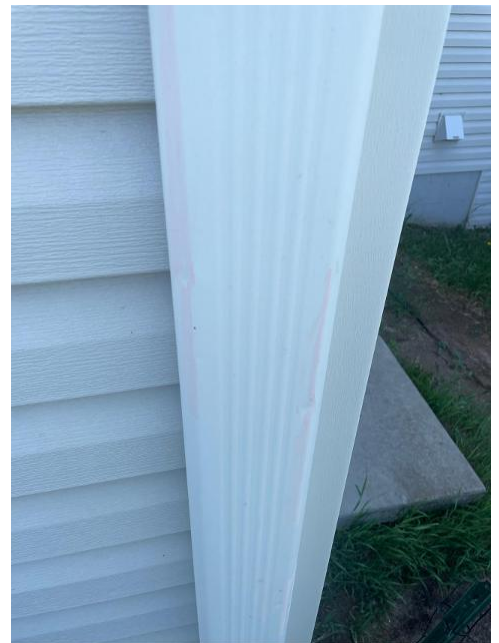
Elevation - Right - Downspout

Storm related damage caused by Hail

Condition: Fair

Damaged : 20 of 20 LF

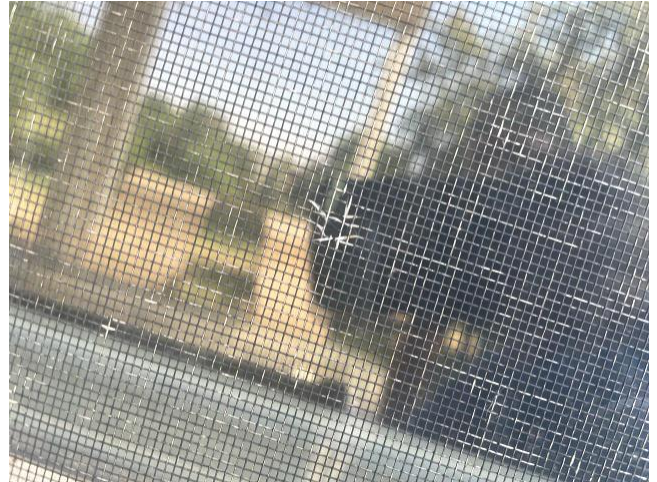
Elevation - Window - Back - Item Photo

Storm related damage caused by Hail

Condition: Fair

Damage to Screen

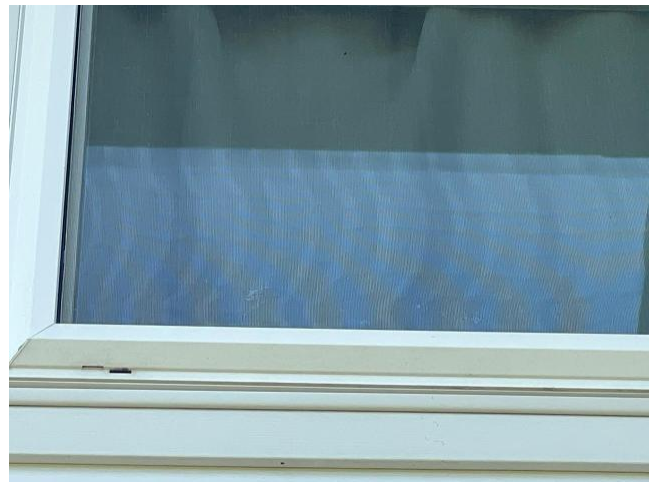
Elevation - Window - Back - Item Photo

Storm related damage caused by Hail

Condition: Fair

Damage to Screen

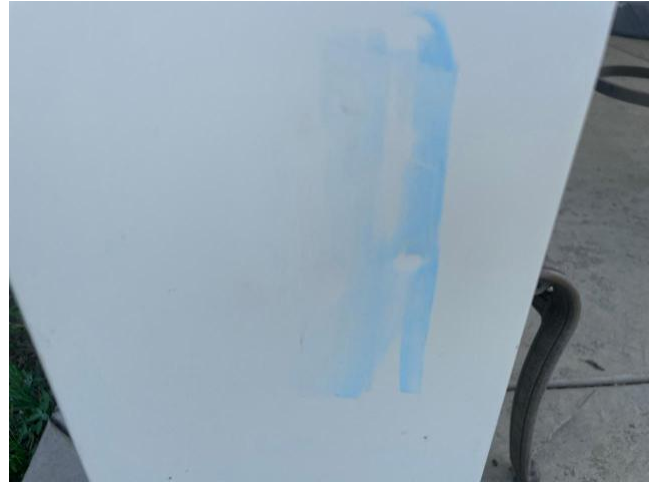
Elevation - patio columns - Back - Insured Representative Considerations

Contractor included for damage consideration.
Seek Now Inspector believes to be mechanical marks.

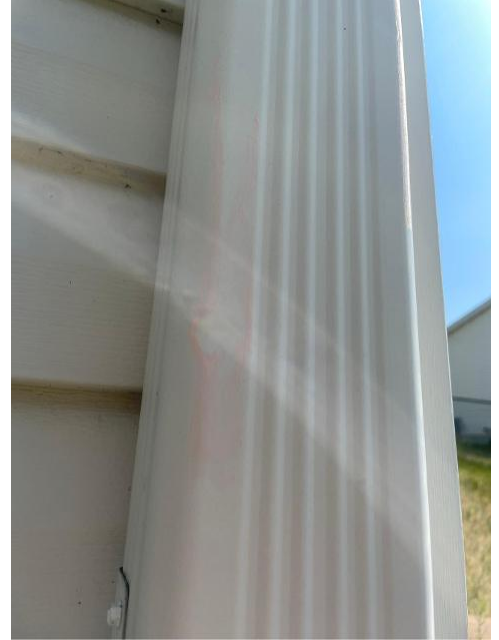
Elevation - Back - Downspout

Storm related damage caused by Hail

Condition: Fair

Damaged : 42 of 42 LF

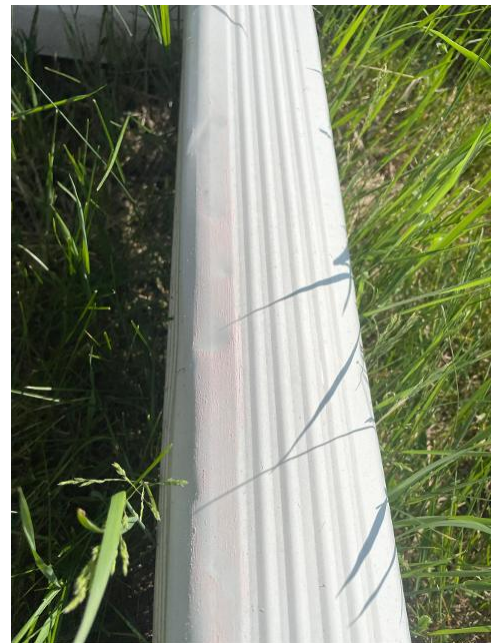
Elevation - Back - Downspout

Storm related damage caused by Hail

Condition: Fair

Damaged : 42 of 42 LF

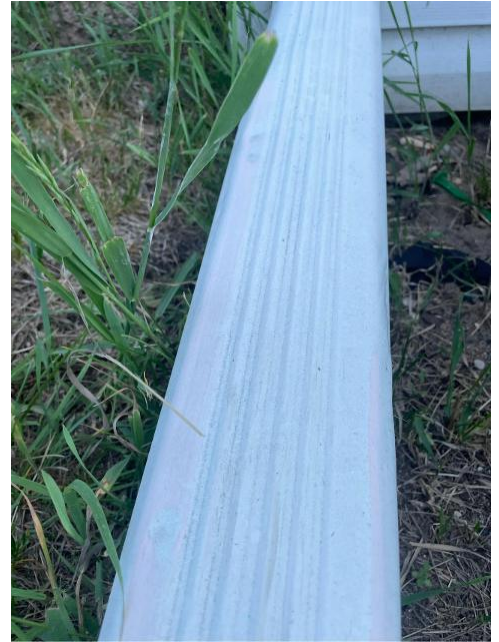
Elevation - Back - Downspout

Storm related damage caused by Hail

Condition: Fair

Damaged : 42 of 42 LF

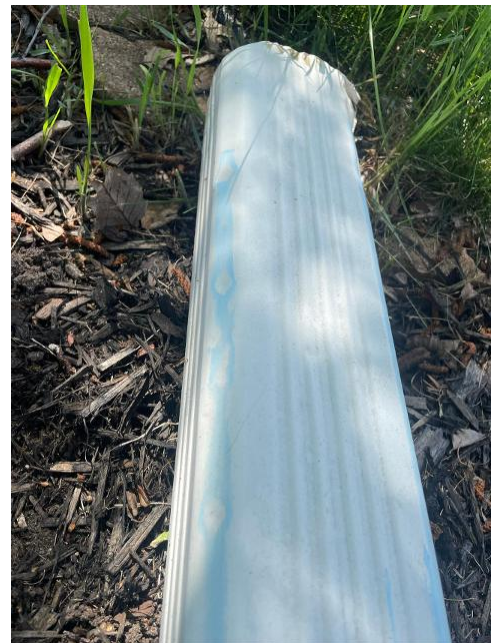
Elevation - Left - Downspout

Storm related damage caused by Hail

Condition: Fair

Damaged : 13 of 13 LF

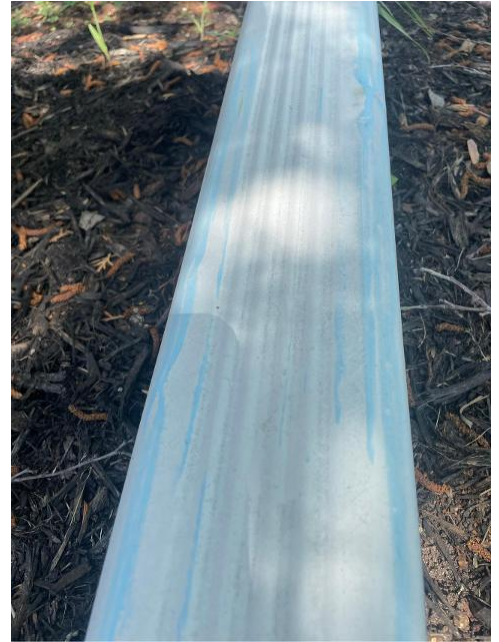
Elevation - Left - Downspout

Storm related damage caused by Hail

Condition: Fair

Damaged : 13 of 13 LF

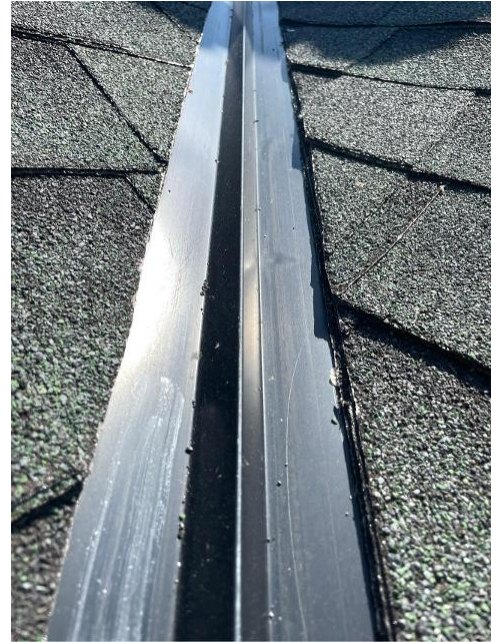
Open Valley

Storm related damage caused by Hail

Condition: Fair

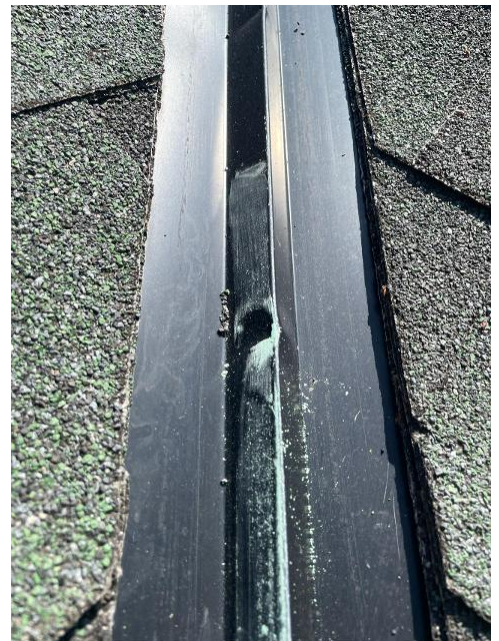
Open Valley

Storm related damage caused by Hail

Condition: Fair

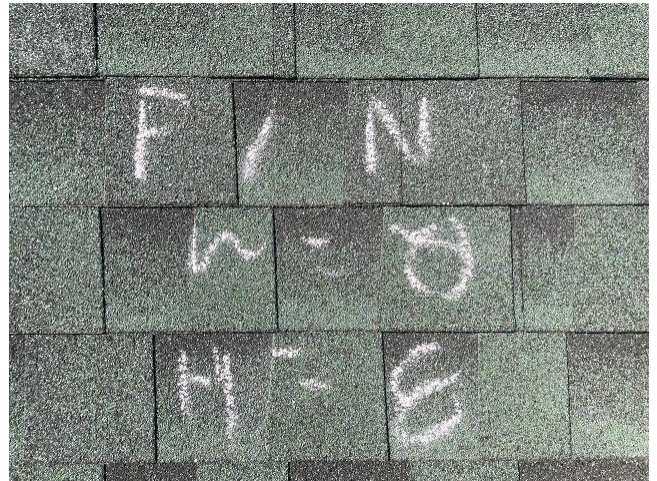
Front - 1st Story Slope - Damage Assessment

Hail - 8

Wind - 0

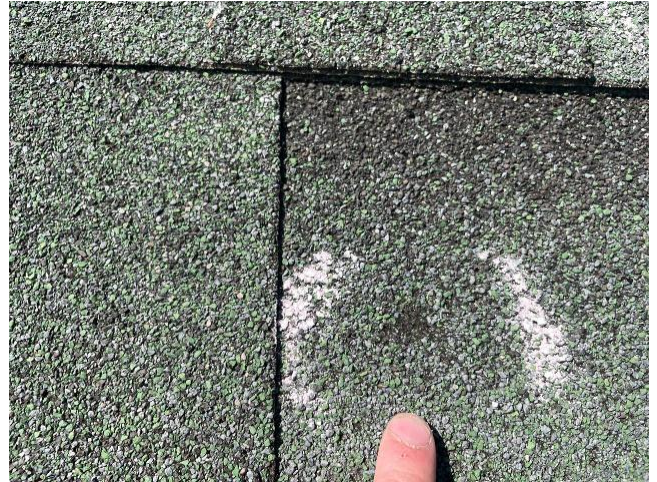
Front - 1st Story Slope - Damage

Storm Related Damage caused by Hail
June 1, 2023

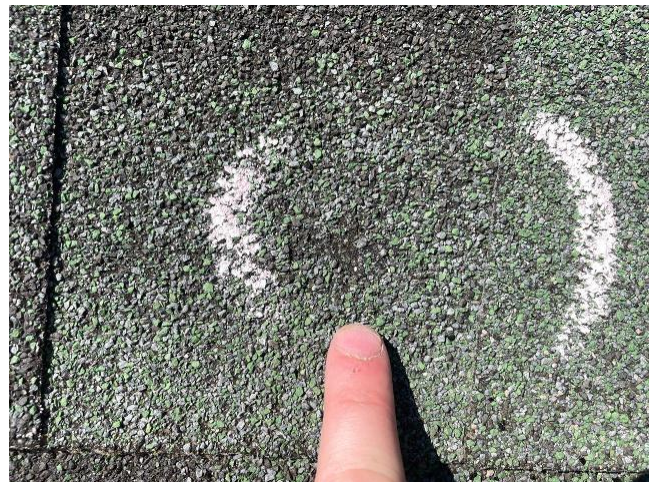
Front - 1st Story Slope - Damage

Storm Related Damage caused by Hail
June 1, 2023

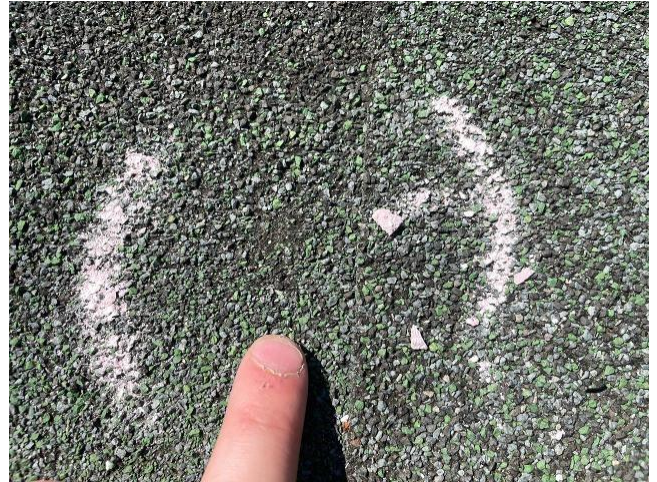
Front - 1st Story Slope - Damage

Storm Related Damage caused by Hail
June 1, 2023

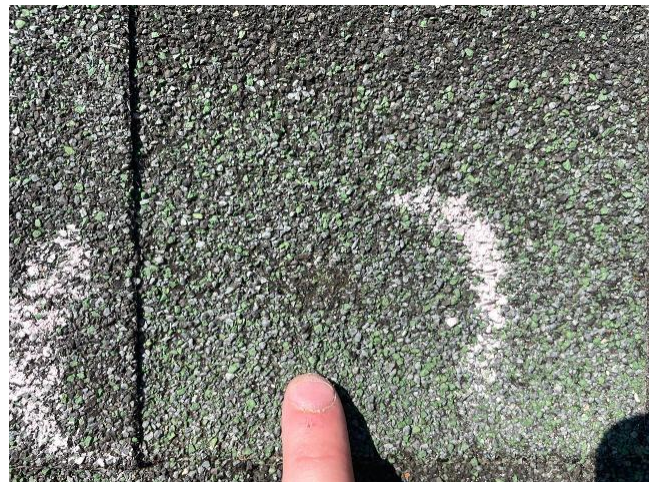
Front - 1st Story Slope - Damage

Storm Related Damage caused by Hail
June 1, 2023

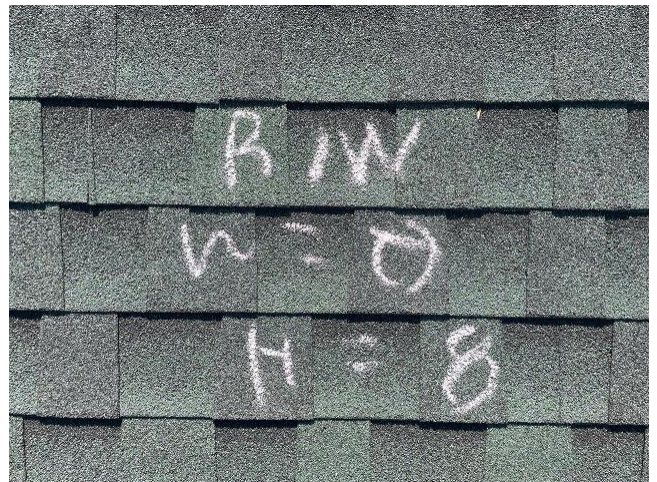
Right - 1st Story Slope - Damage Assessment

Hail - 8
Wind - 0
June 1, 2023

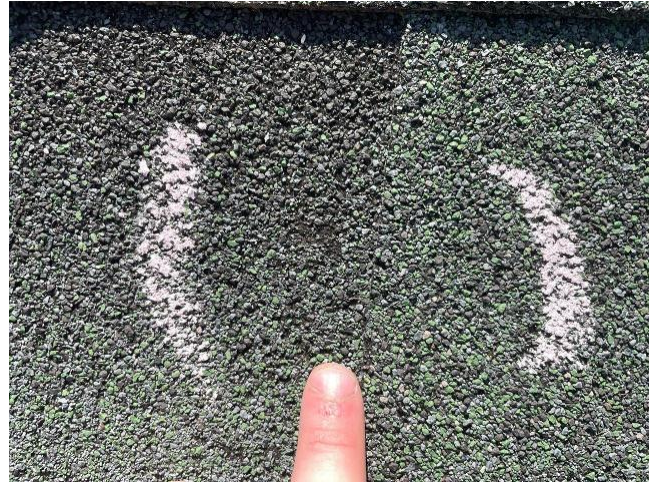
Right - 1st Story Slope - Damage

Storm Related Damage caused by Hail
June 1, 2023

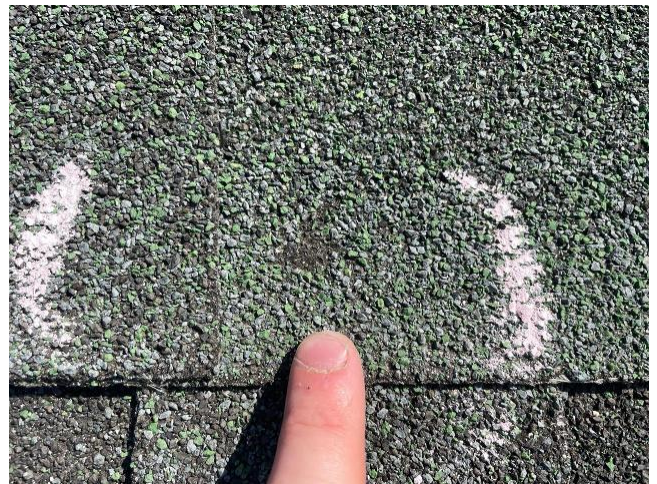
Right - 1st Story Slope - Damage

Storm Related Damage caused by Hail
June 1, 2023

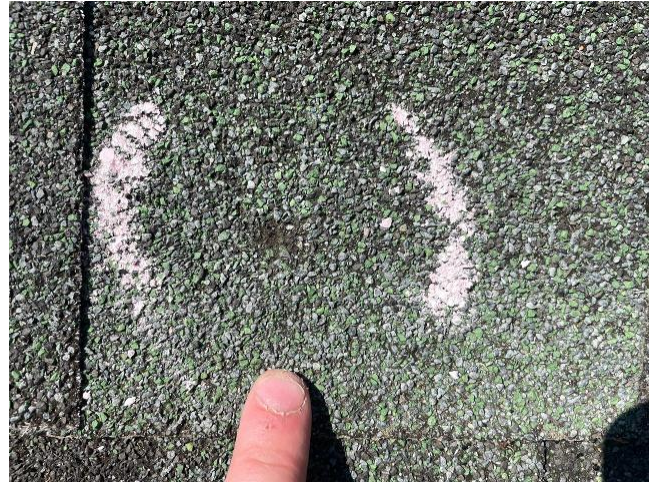
Right - 1st Story Slope - Damage

Storm Related Damage caused by Hail
June 1, 2023

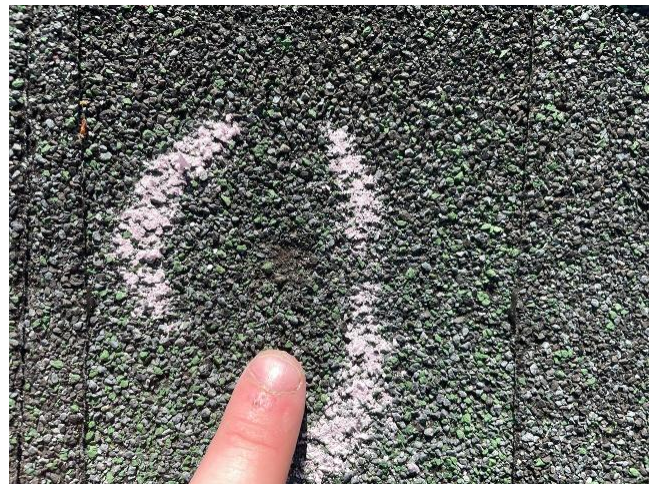
Right - 1st Story Slope - Damage

Storm Related Damage caused by Hail
June 1, 2023

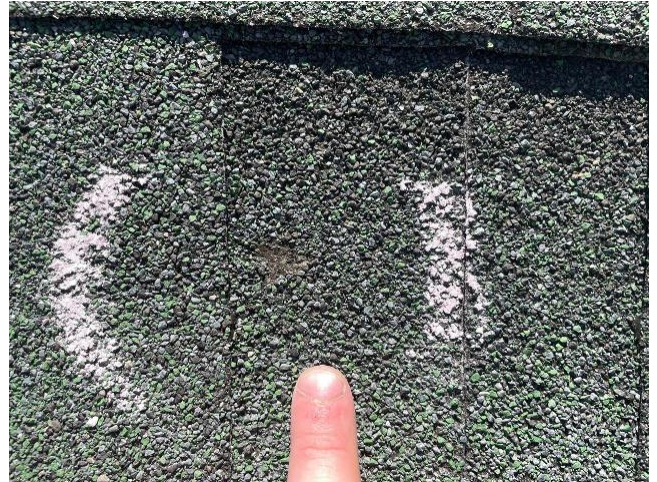
Right - 1st Story Slope - Damage

Storm Related Damage caused by Hail
June 1, 2023

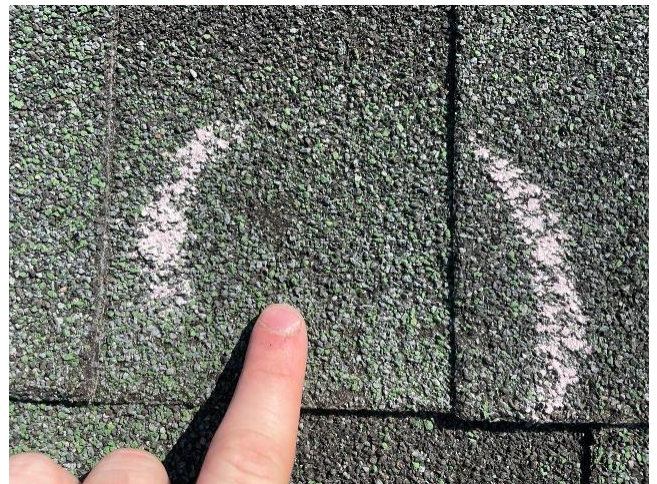
Back - 1st Story Slope - Damage

Storm Related Damage caused by Hail

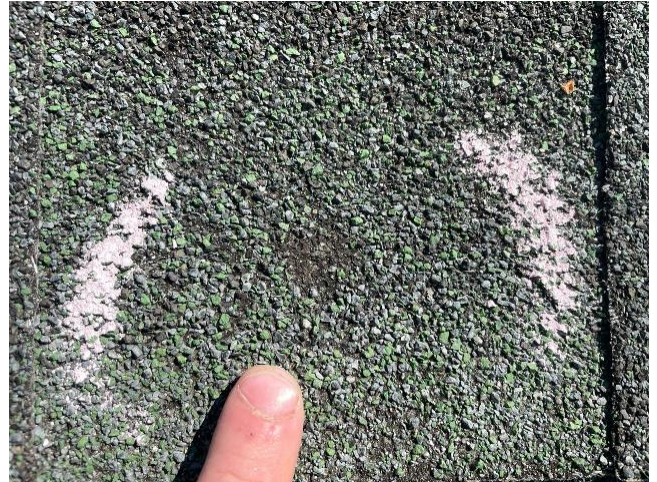
Back - 1st Story Slope - Damage

Storm Related Damage caused by Hail
June 1, 2023

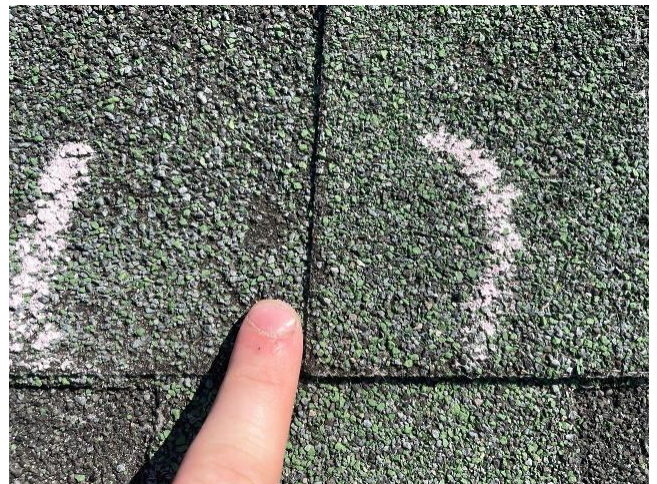
Back - 1st Story Slope - Damage

Storm Related Damage caused by Hail
June 1, 2023

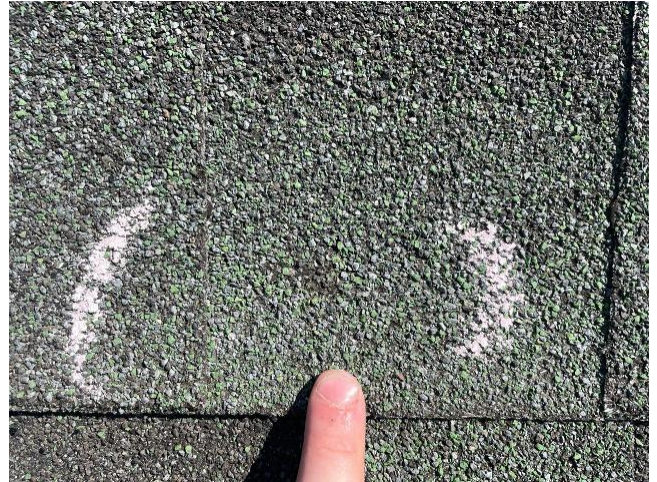
Back - 1st Story Slope - Damage

Storm Related Damage caused by Hail
June 1, 2023

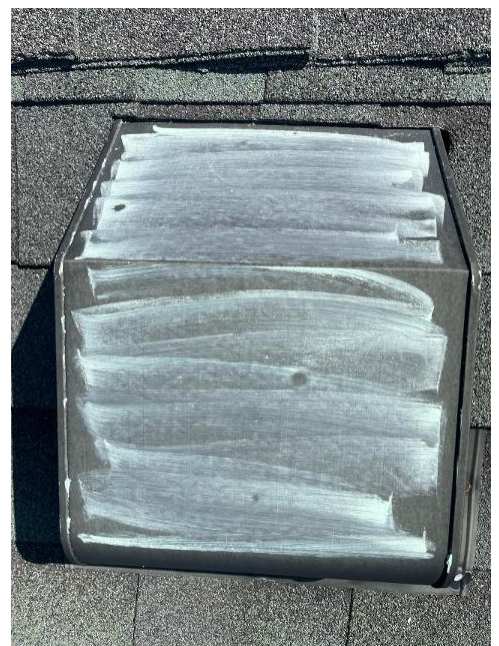
Accessory - Back - 1st Story Slope

Storm related damage caused by hail

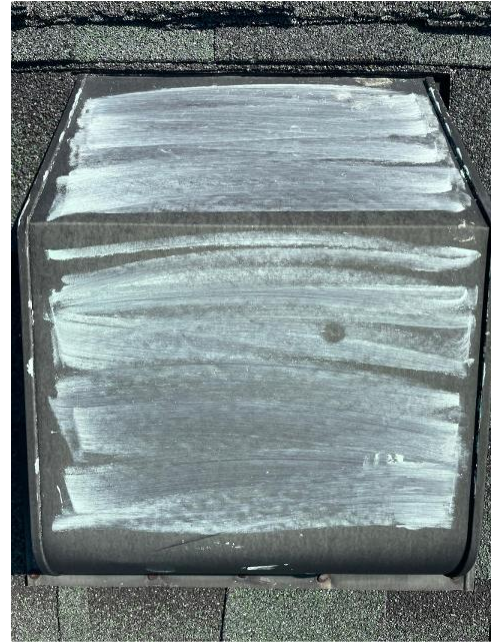
Accessory - Back - 1st Story Slope

Storm related damage caused by hail

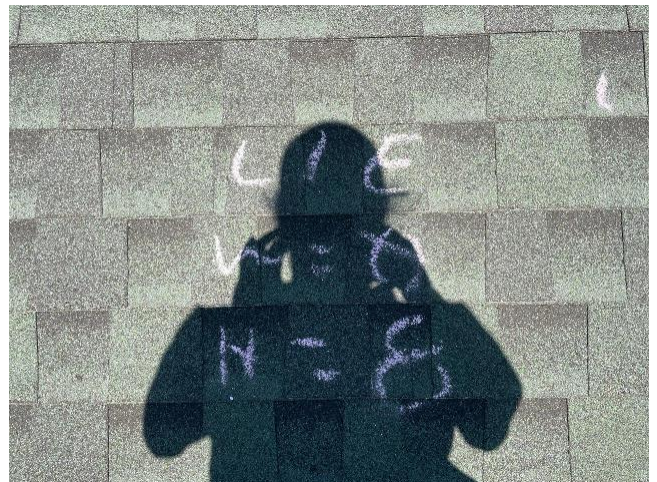
Left - 1st Story Slope - Damage Assessment

Hail - 8

Wind - 0

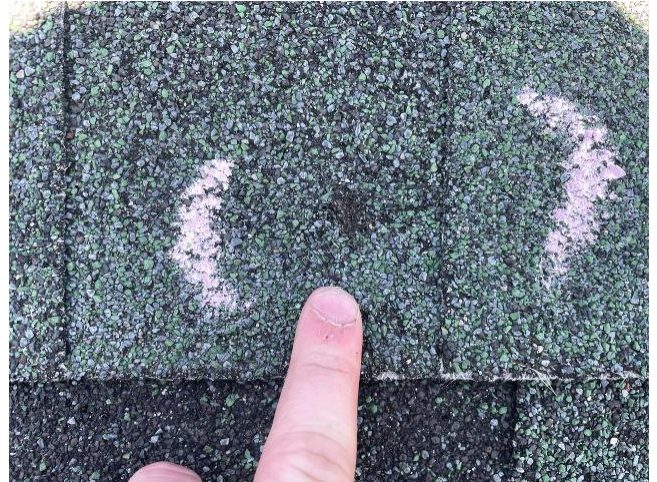
Left - 1st Story Slope - Damage

Storm Related Damage caused by Hail
June 1, 2023

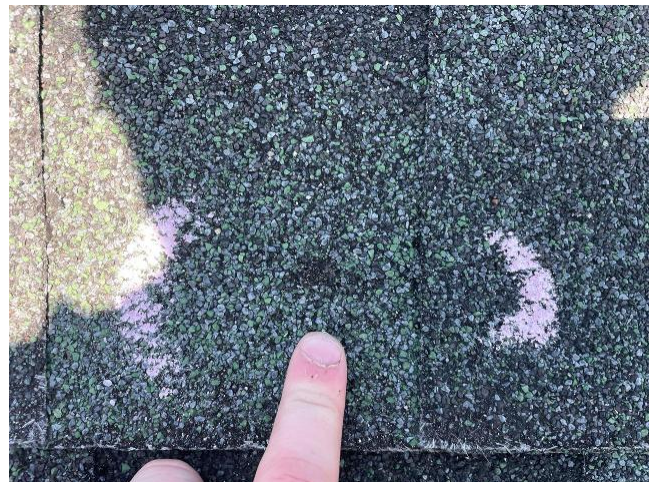
Left - 1st Story Slope - Damage

Storm Related Damage caused by Hail
June 1, 2023

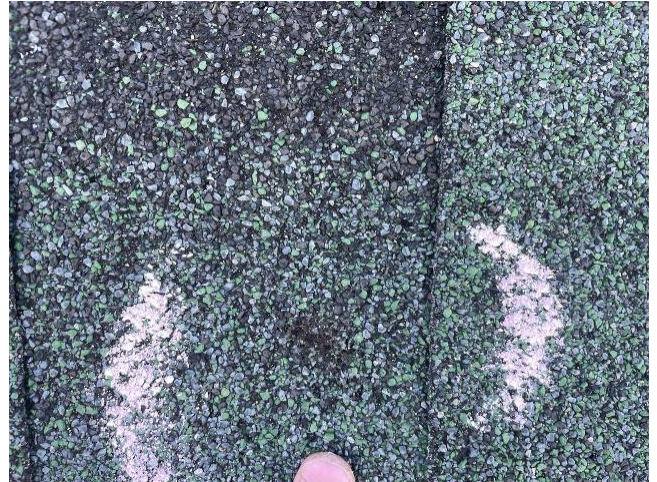
Left - 1st Story Slope - Damage

Storm Related Damage caused by Hail
June 1, 2023

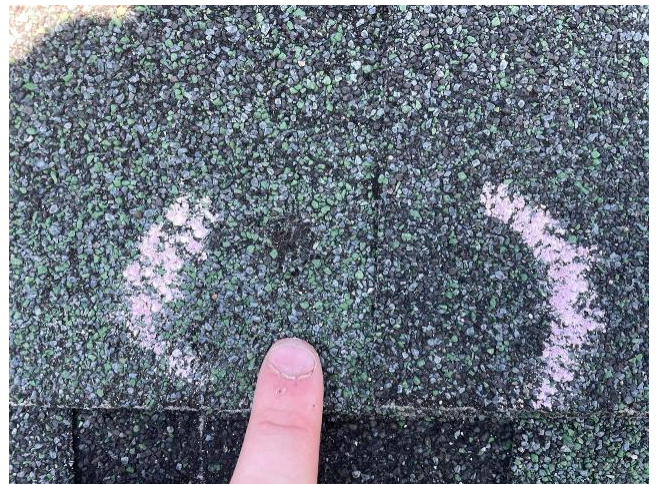
Left - 1st Story Slope - Damage

Storm Related Damage caused by Hail
June 1, 2023
