Seek Now Maestro Report

Solo Inspection

Claim: 00000000

Loss Location : 123 Address Lane

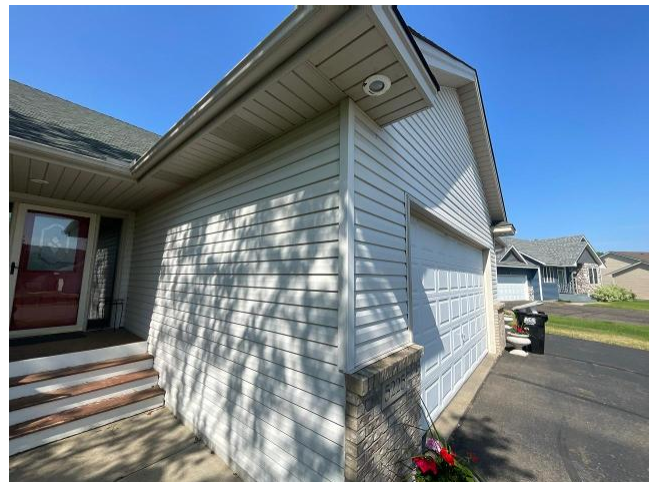
Elevation - Materials - Front - Condition

Condition: Good

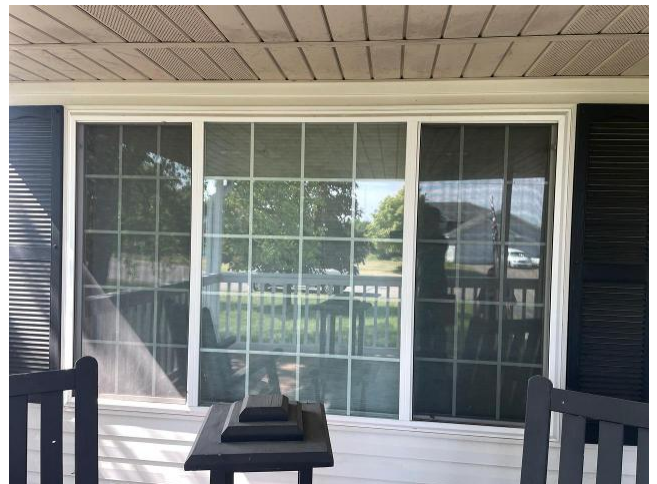
Elevation - Materials - Front - Damage

Storm related damage caused by Hail

Total Count: 3

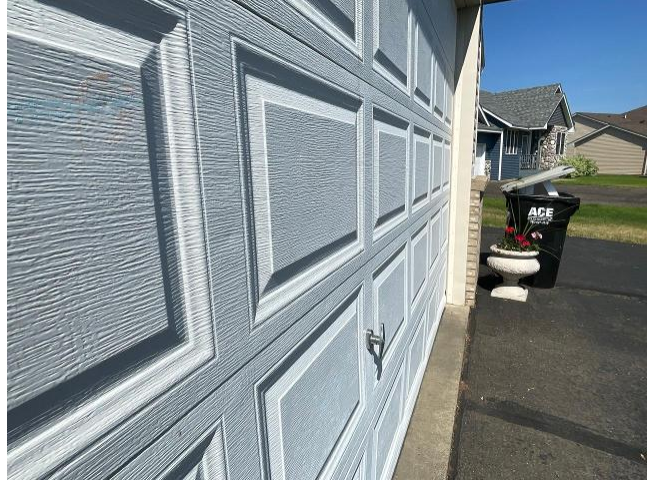
Elevation - Garage Door - Front - Item Photo

Storm related damage caused by Hail

Condition: Fair

Damage to Panel and Wrap

Total Count: 2

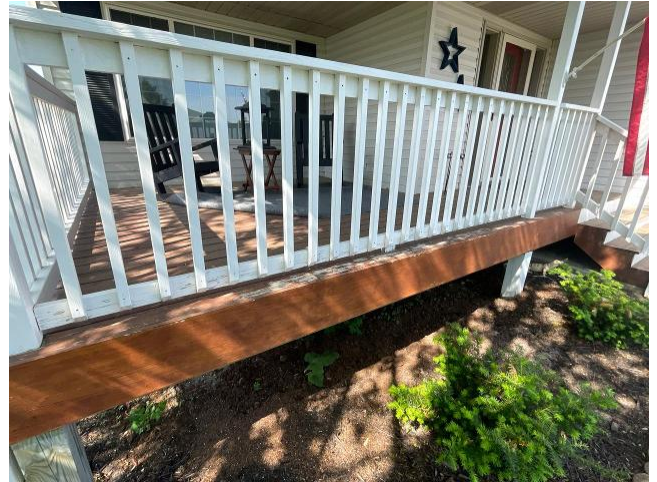
Elevation - Porch - Front - Item Photo

Condition: Fair

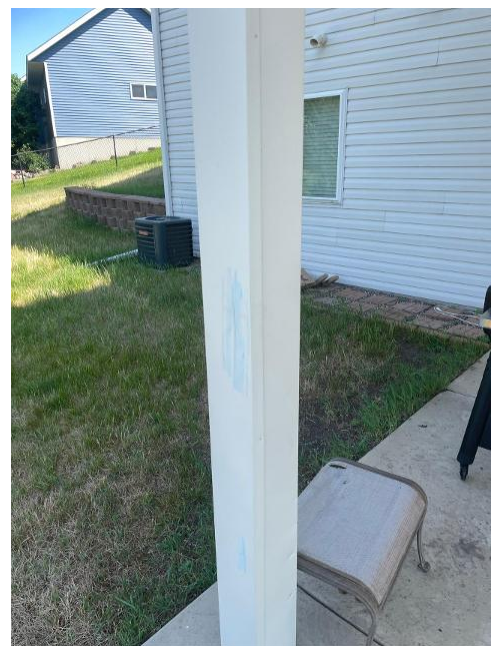
Elevation - patio columns - Back - Item Photo

Condition: Good

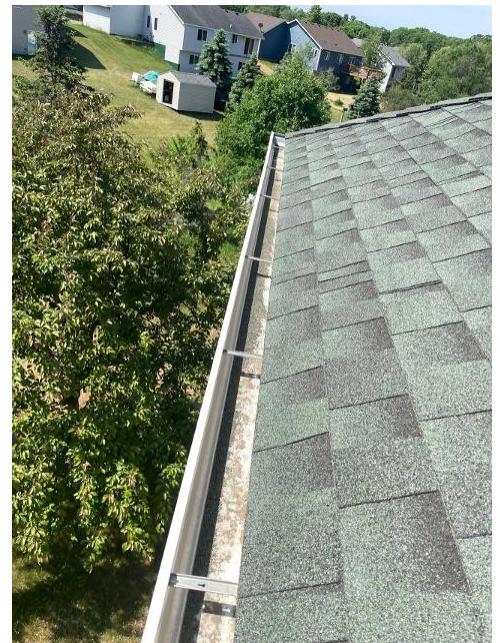
Elevation - Left - Gutter

Condition: Fair

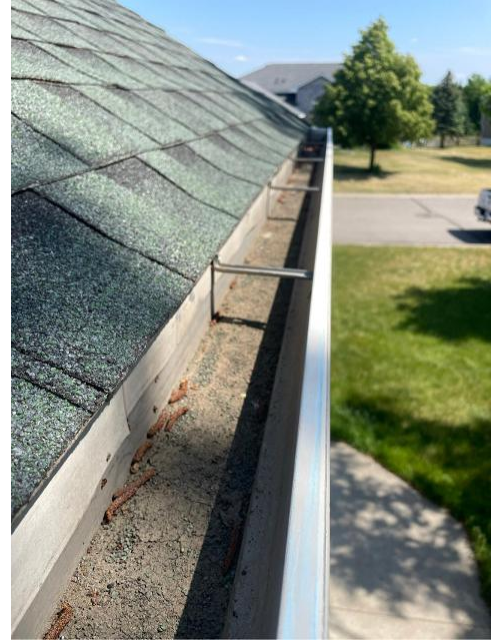
Elevation - Left - Gutter

Condition: Good

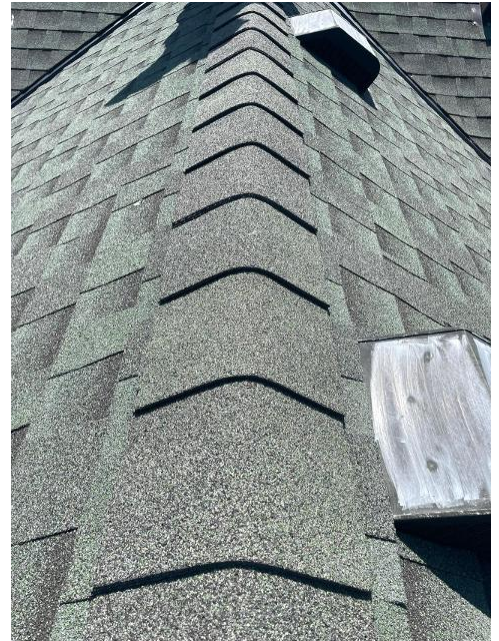
Hip & Ridge Run Overview

Front/Back
Hi-Def Cap
Fair Condition
No Damage
June 1, 2023

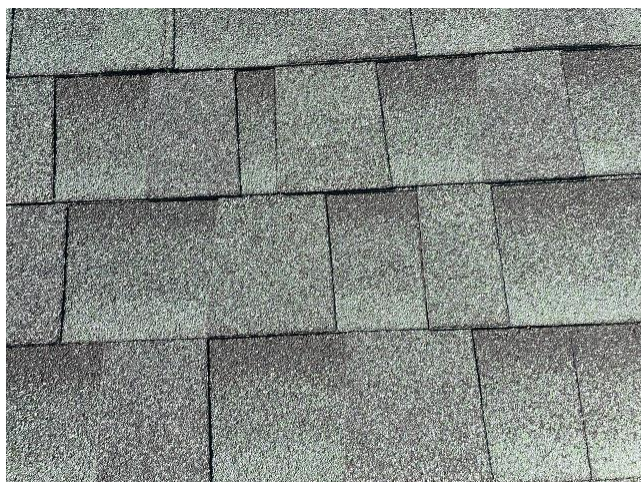
Front - 1st Story Slope - Roof Condition

Fair Condition

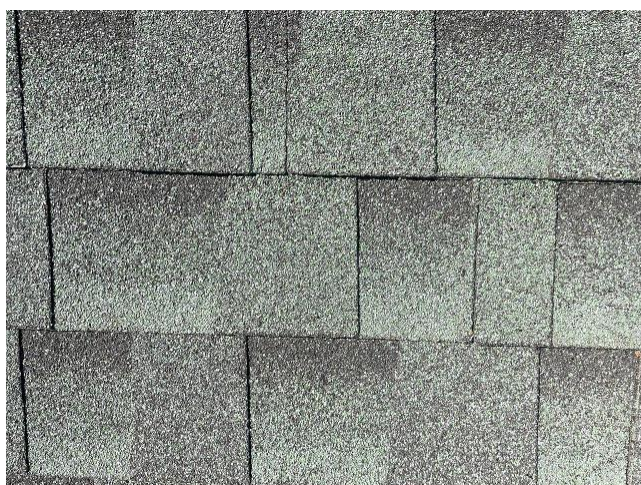
Front - 1st Story Slope - Roof Condition

Fair Condition

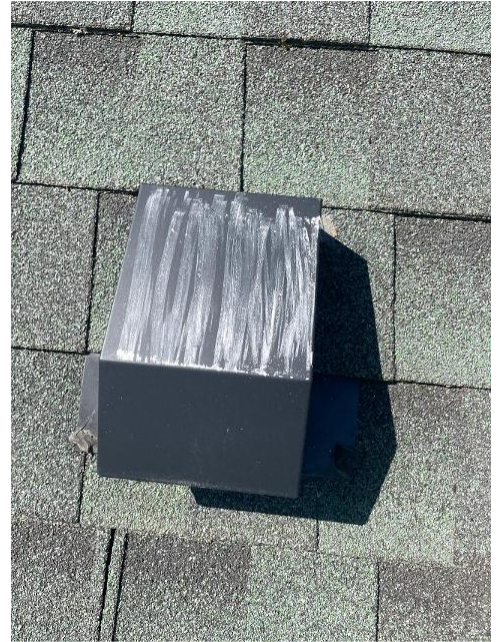
Accessory - Front - 1st Story Slope

No Damage

Size: 5.0"

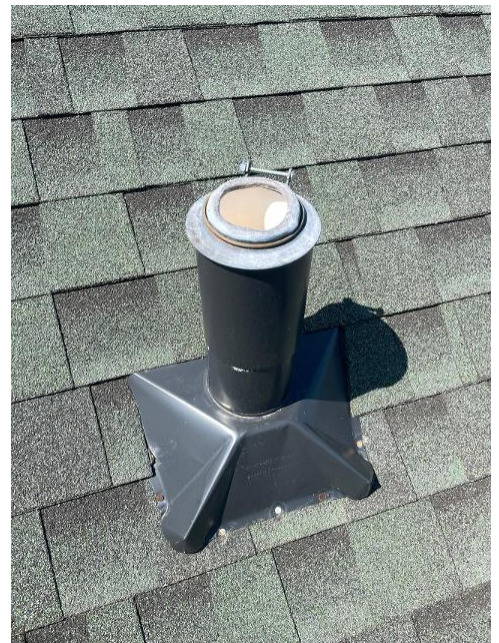
Accessory - Front - 1st Story Slope

Pipe Boot

No Damage

Size: 3.0"

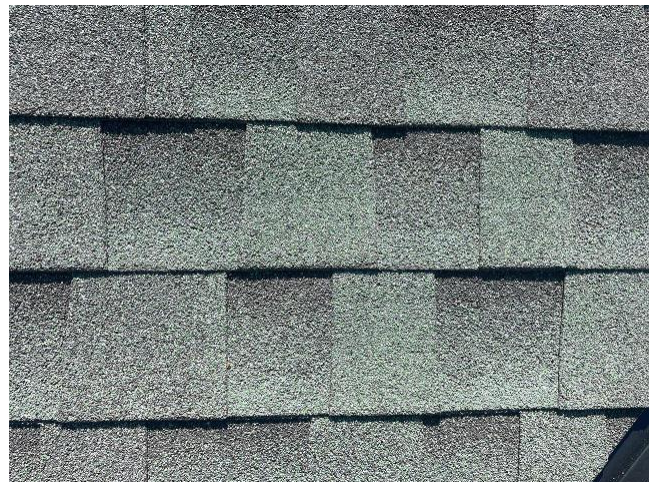
Right - 1st Story Slope - Roof Condition

Fair Condition
June 1, 2023

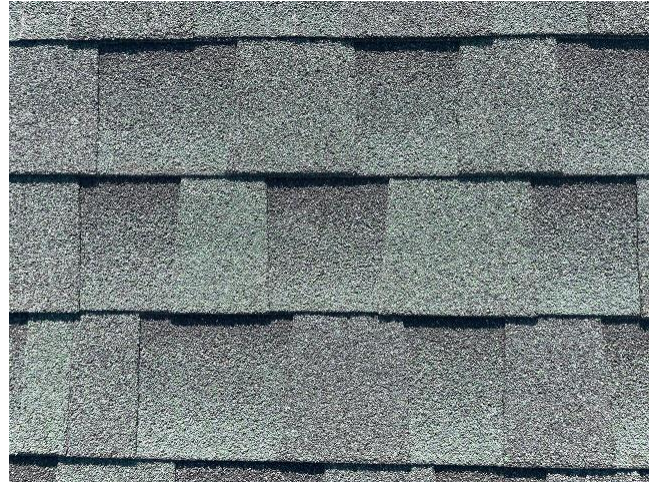
Right - 1st Story Slope - Roof Condition

Fair Condition

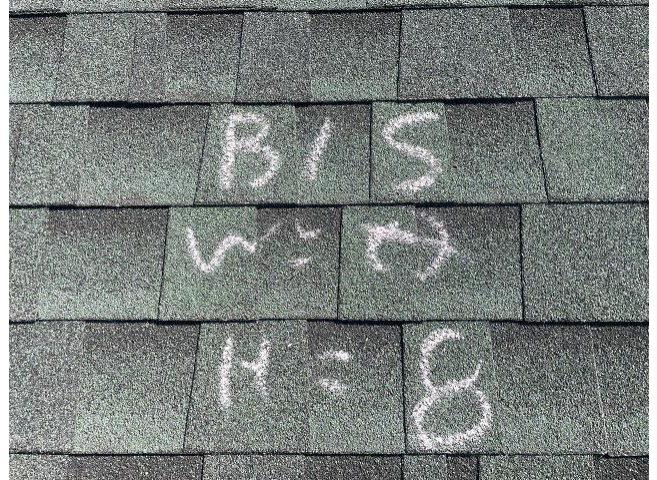
Back - 1st Story Slope - Damage Assessment

Wind - 0

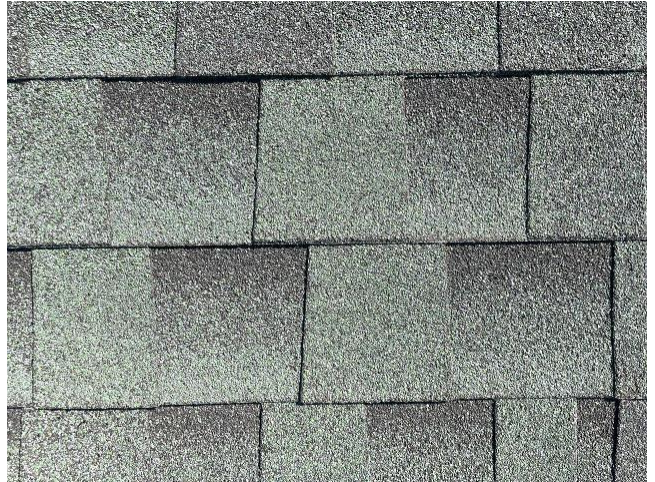
Back - 1st Story Slope - Roof Condition

Fair Condition

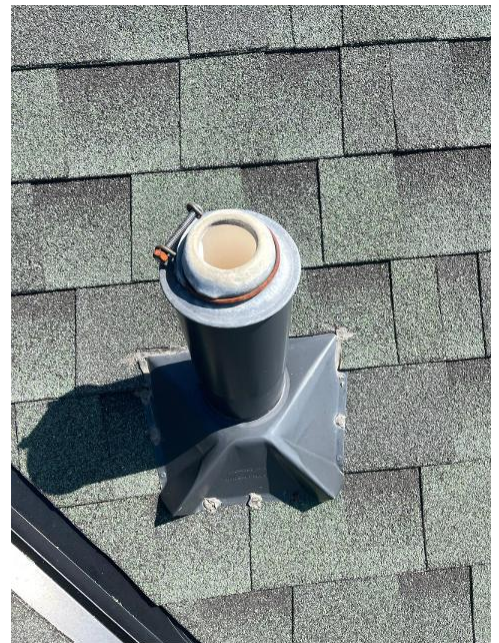
Accessory - Back - 1st Story Slope

Pipe Boot

No Damage

Size: 2.0"

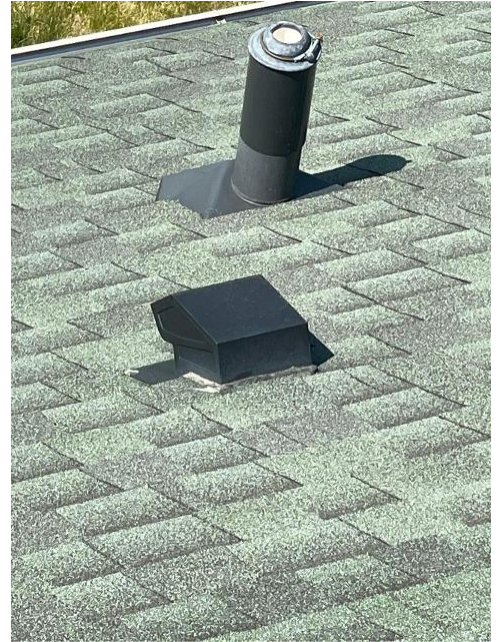
Accessory - Back - 1st Story Slope

No Damage

Size: 5.0"

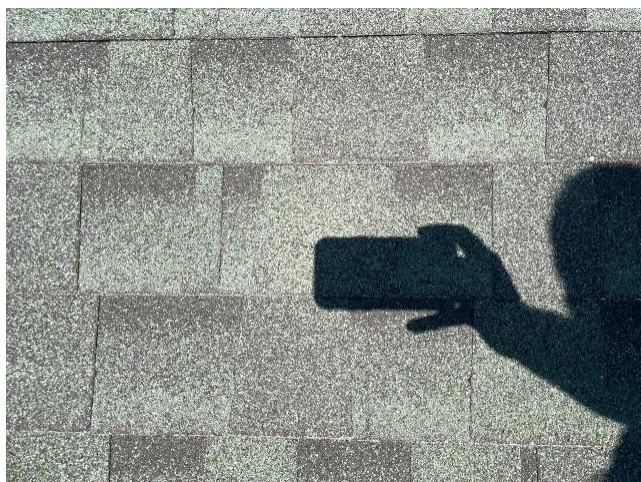
Left - 1st Story Slope - Roof Condition

Fair Condition

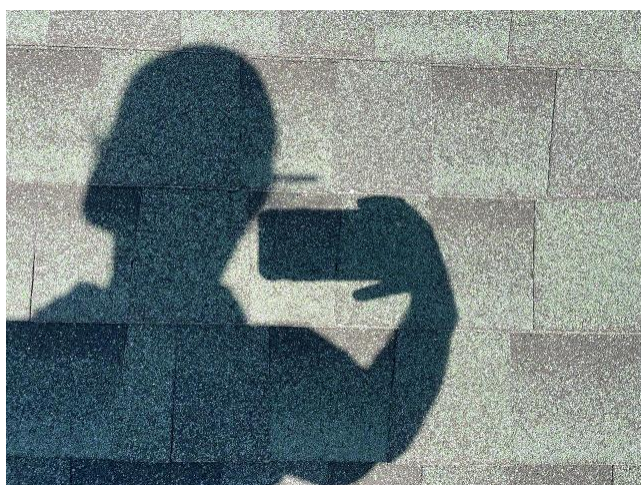
Left - 1st Story Slope - Roof Condition

Fair Condition
